# The failure of a twenty-one year old anchored sheet pile quay wall on the Thames

Eur Ing A D BARLEY, Geotechnical Specialist

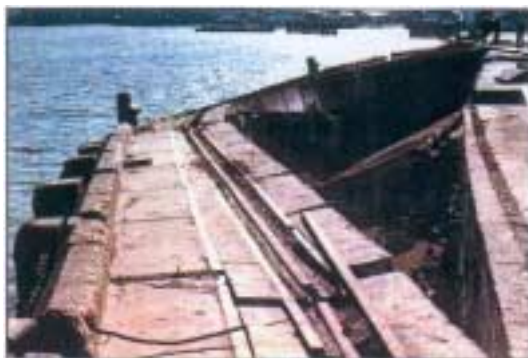
Early in the week beginning 26 Feb 1990, an employee working on the quay, noticed a crack in the concrete paving behind the sheet pile quay wall and in front of the large service duct running along the quay edge. Two days later engineers visited the site and, by this time, a 10m length of sheet piling had moved away from the service duct, by up to 2 metres. A day later, the sheet piles complete with heavy R.C. capping beam and outer crane rail had fallen further away from the quay leaving a gap in between the piles and the quay behind (Photo 1). Delivery of a pump was arranged to dewater behind the piles after high tide to reduce the quantity of water retained which was itself accelerating failure. A slight tear appeared in the top of the sheet piles at the final downstream limit of failure.

**Photo 1: Wall Failure after 6 days (right)**

Arrangements were made to bring heavy chains to the site to provide external restraint to the sheet pile wall and prevent the failure progressing. This was particularly critical in the upstream direction towards the location of the existing crane. Excessive settlement was observed over a large area of the concrete paving (up to approx 500mm) extending some 15m "in shore" from the sheet pile wall settlement and a further 30 m in an upstream direction from the initial wall failure zone.

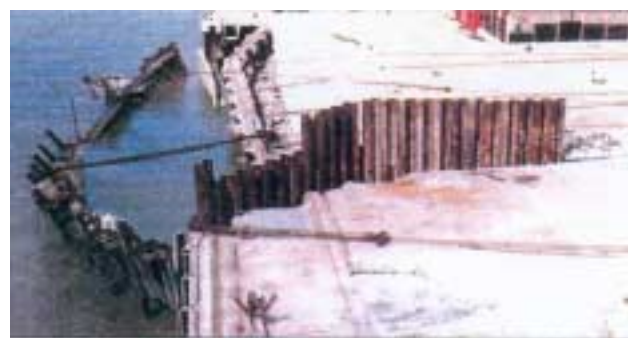
**Photo 2: Overall view of wall failure after about 2 weeks (left)**

The situation was monitored over the weekend and the first failure of the 1.5 m square R.C. service duct was observed. Failure was by a combination of vertical settlement and outward collapse into the void formed behind the sheet pile wall.

Two sets of chains and tie rods were provided the following week and fixed from the two bollards in the failed capping beam to two exposed pile caps some 30m behind the quay. Plant was then mobilised to drive a line of sheet piles normal to the quay in an effort to prevent the failure progressing closer to the crane. (Photo 2).

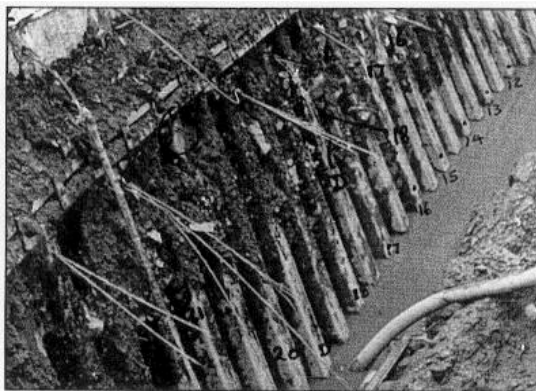
Investigation to establish factors contributing towards the wall failure commenced by removal of a number of complete anchor head units from the sheet pile in-pans in the area where the collapse had started. (Photo 3 and 4).

**Photo 3: Severed anchor tendons after wall failure**

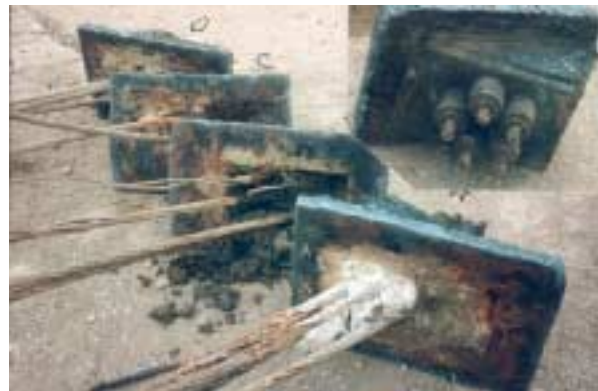
Access to the outside of the wall to inspect all exposed anchor heads was provided by the contractors vessel whilst during the low tide period safe access to the inner void allowed a detailed study of all exposed anchors, the inner steel work, and the R C components.

**Photo 4: Anchor heads removed from the wall for inspection.**

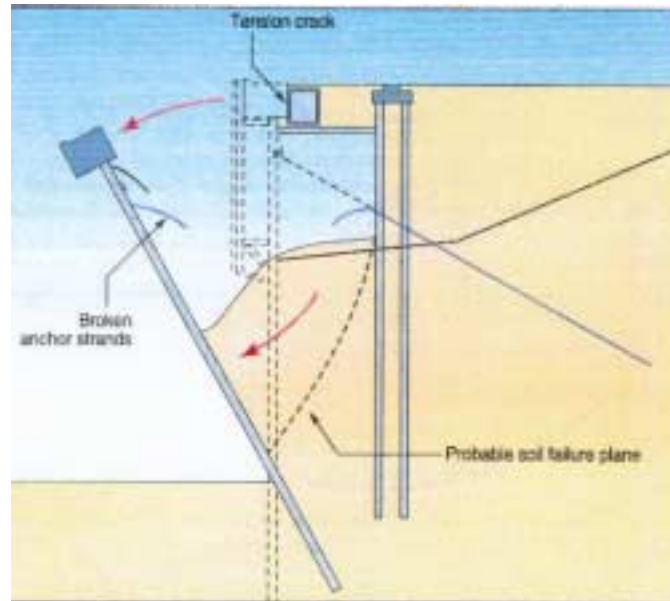
The structure was designed to provide a 15 m deep shipping berth complete with crane rail and service duct, and is consistent with those commonly utilised (Fig 1). The 142m length of sheet piles, complete with heavy R C capping beam, provided the quay edge and supported the outer crane rail; whilst pairs of driven "H" piles, complete with R C beam, supported the inner crane rail. In between was located the rectangular R C service duct, and a thin R C slab covered the entire quay area. Lateral restraint was provided by a combination of a row of ground anchors installed 3 m below quay level, the toe fixity of the driven sheet piles, the pairs of driven H piles and the general stiffness of the composite structure.

**Fig 1: Original anchored sheet pile wall with supported crane rails and service duct. Failure mode portrayed.**

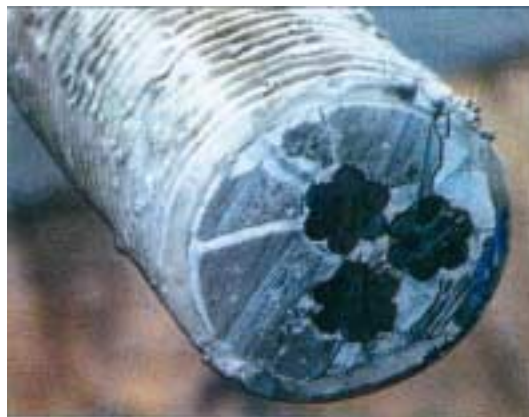
In acknowledgement that the free length tendon was vulnerable to corrosion, a 60mm diameter corrugated plastic duct was threaded over the strands for a 9m length prior to installation (Photo 5).

**Photo 5: Strands encapsulated in grouted duct for free length protection.**

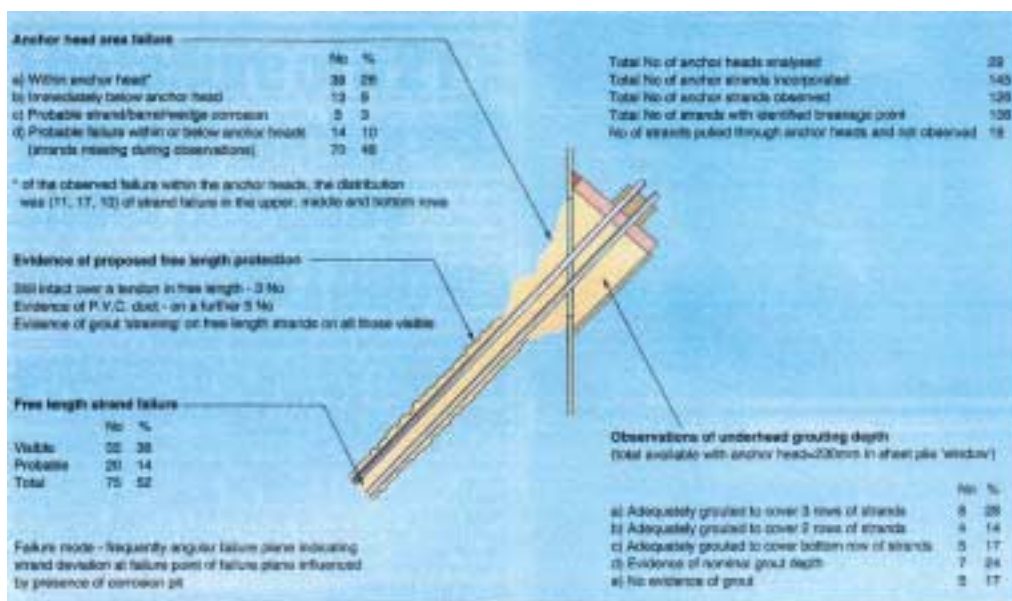
**Fig 2: Section through anchor head and summary of location of strand failures (weakest link).**

Observations identified serious shortcomings in the corrosion protection after 22 years of "service", although in some areas it was apparent that underhead grouting had never attained the intended void filling, nor had the free length duct diameter been compatible with the strand distribution required in the anchor head plate. A statistical summary of the locations of strand failures, and of the effectiveness of the underhead grouting, and the state of the prestressing barrels/wedges is presented in Fig 2.

- i) the failure of the epoxy resin coating over the external anchorhead;
- ii) the inadequacy of the underhead grouting;
- iii) a weakness at the junction between the underhead grouting and the upper free length protection.

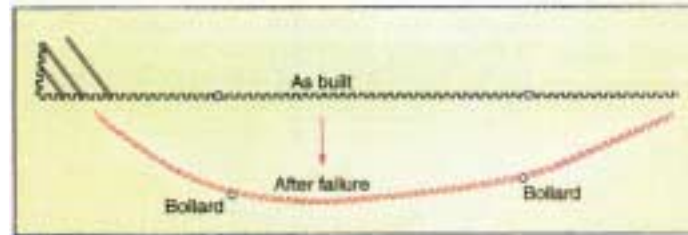
Fig 3 presents a plan view of the locations of the anchors and the wall both prior to and after failure. In addition to the 29 wall anchors, the two bollards were each restrained by a pair of anchors which also failed as collapse progressed.

**Fig 3: Plan view of anchors before and after wall failure.**
