## Efficiency of Prestressing Heads

by Anthony (Tony) Barley Single Bore Multiple Anchors Ltd., Harrogate, England

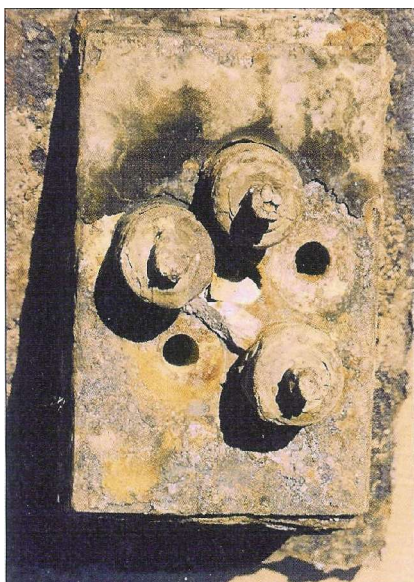
Photograph 1. Corrosion effects

Photograph 1 illustrates the effect of such corrosion

- The strand section

was reduced due to corrosion

- The wedges were prevented from pulling into the head
- The strands pulled through the wedges and monostrand heads fell off the anchor head plate

The wedge to tapered hole interface also requires oiling or greasing such that it *lasts the life time of the structure*. Unless the wedge can freely move into the taper hole, there will be a breakdown in the grip efficiency because the wedge cannot increase its lateral pressure at the wedge/strand interface.

Any introduction of cement, grout, concrete or other setting product into the prestressing head reduces the performance of the head since it may prevent free movement of the wedge.

Furthermore, should oil or grease not be present, then there is also a risk of corrosion of the wedge/taper hole interface. Both these occurrences prevent free movement of the wedges and reduce the prestressing head performance.

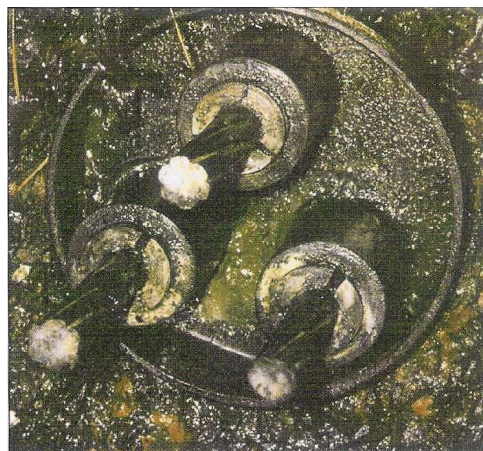
Photograph 2. Shows benefits when using grease filled protection caps.

Photograph 2 provides a fine example of the benefits of the use of grease filled protection caps.

This 16 year old inspected head was located low in the tidal range at Aberdeen Harbour and therefore subjected to aggressive environmental conditions (visible adjacent to the cap). The only part requiring replacement was the corroded steel head cap which was replaced by non-corrodible glass reinforced fibre caps.

We hope the Committee agrees with some of the above conclusions and considers recommending the use of grease filled caps on all permanent anchor projects.
